NIST NCSTAR 1-5A

**Federal Building and Fire Safety Investigation of
the World Trade Center Disaster**

Visual Evidence, Damage Estimates, And Timeline Analysis

William M. Pitts
Kathryn M. Butler
Valentine Junker

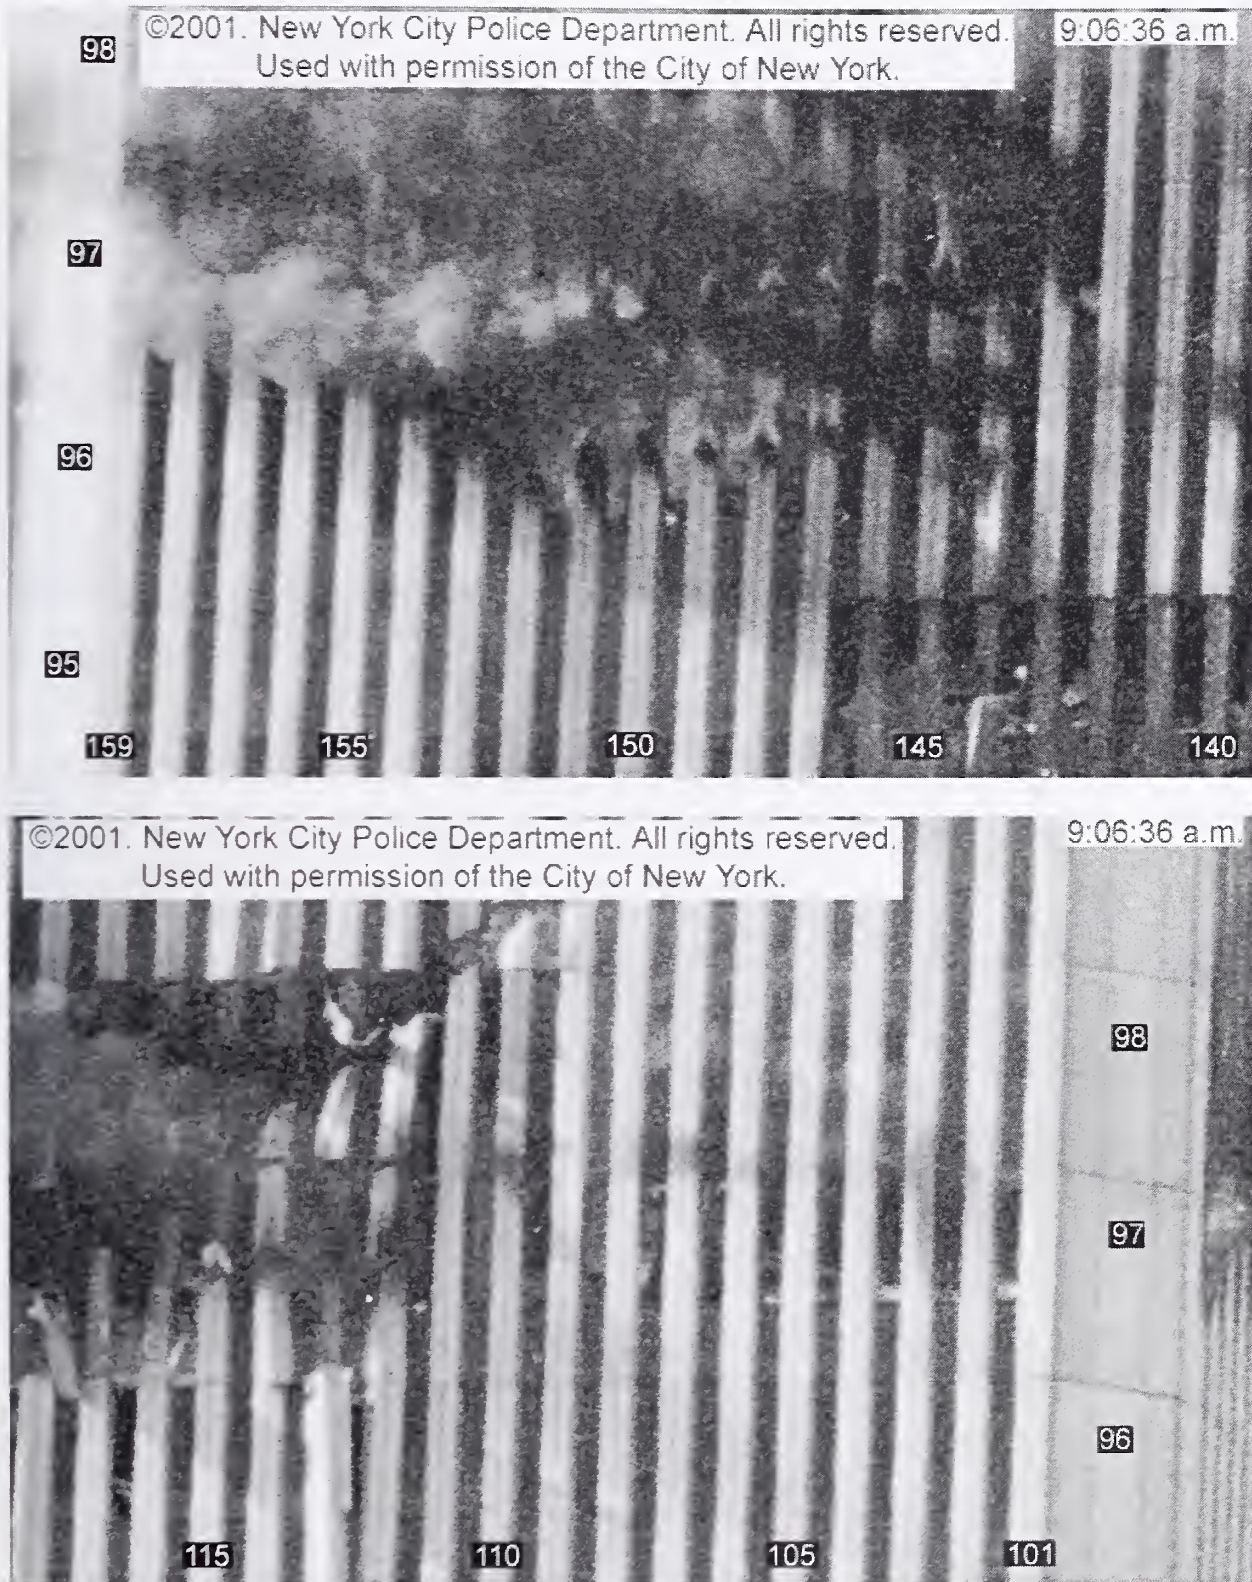
Another prominent feature in Figure 8-18 is the row of carets running across the tops of the column covers. These provide a clear visual indication of how intense the earlier fires in these windows were. It is interesting to compare the appearance of the column covers in this area with those on the 97th floor to the west of the aircraft impact cavity. A blowup of this area is also included in Figure 8-18. The columns are barely marked despite the presence of an active fire in the area for many minutes. This suggests that this fire must be venting somewhere other than through the open windows on the north face. As already discussed, and can be seen in the figure, flames and smoke were coming from this area on the west face of the tower. The smoke issuing from the right side of the aircraft impact cavity may also be due to effluent from this fire. Comparison of Figure 8-17 with earlier images of the north face shows that the flow of smoke from the cavity had also decreased with time. The pathways of venting are expected to influence the local heating of the exterior columns since the imposed heat flux will vary with changes in the flow direction through the opening. Exhausting fire gases will tend to heat the columns, while in-flowing outside air will cool the columns.

Figure 8-18. Two close-ups of the north face of WTC 1 taken from the photograph in Figure 8-17 show the east and west sides of the face around the 97th floor. The photos have been rotated, enhanced, and column and floor number have been added.

A small fire continues to burn on the 93rd floor around window 93-145. There is also a small spot fire present in window 98-115 on the 98th floor. This window is immediately above the location where an intense fire initially grew on the 97th floor. Since the windows immediately above on the 98th floor were broken out by the aircraft impact, it is reasonable to assume that flames from below ignited this fire.

In-place windows can be seen in Figure 8–18. On the east side of the building window panes are in their frames on the 95th floor as well as on either side of the fire areas on the 96th and 97th floors. On the west side most windows are still in place on the 96th floor and on the 98th and 99th floors at locations removed from the immediate vicinity of the aircraft impact. These observations suggest that windows are only removed when active burning is present in the immediate area of the window.

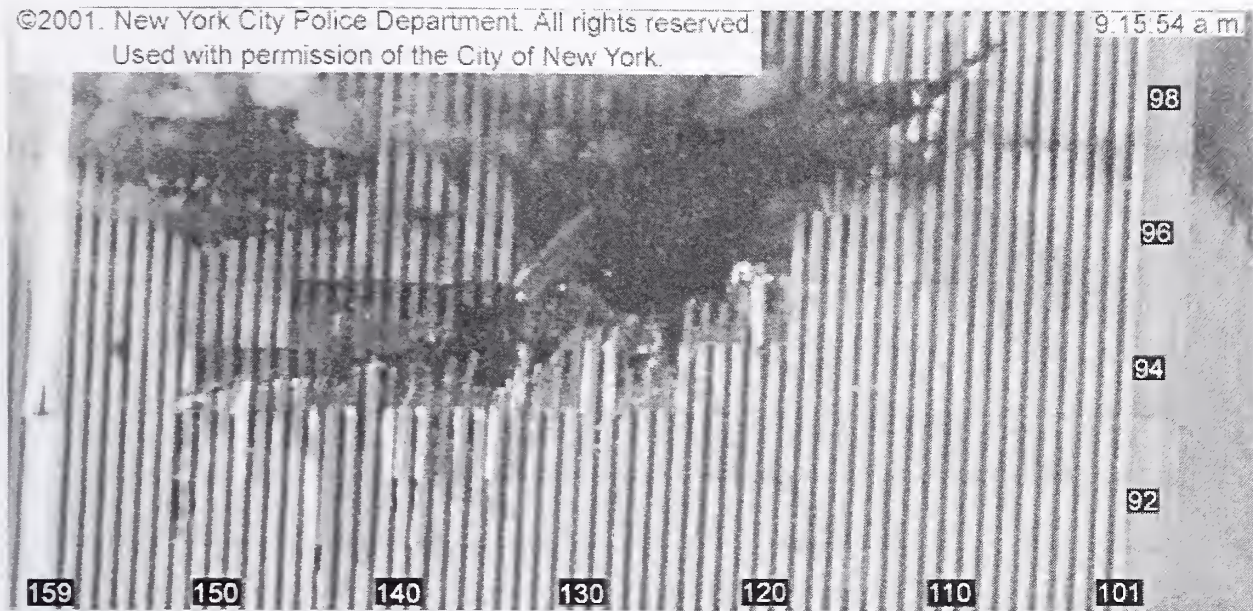
In Appendix L, it can be seen that the number of streamers observed on the north face during the period from 9:03 a.m. to 9:18 a.m. was much decreased from that seen during the preceding fifteen minutes. The streamers that were observed were on the west side of the tower shortly after the fire spread into this area. These observations provide further evidence that streamers typically formed shortly after active fire had broken windows in a given area.

Figure 8-19. An image recorded at 9:15:54 a.m. shows the north face of WTC 1. The original has been cropped, rotated, and enhanced. Column and floor numbers have been added.

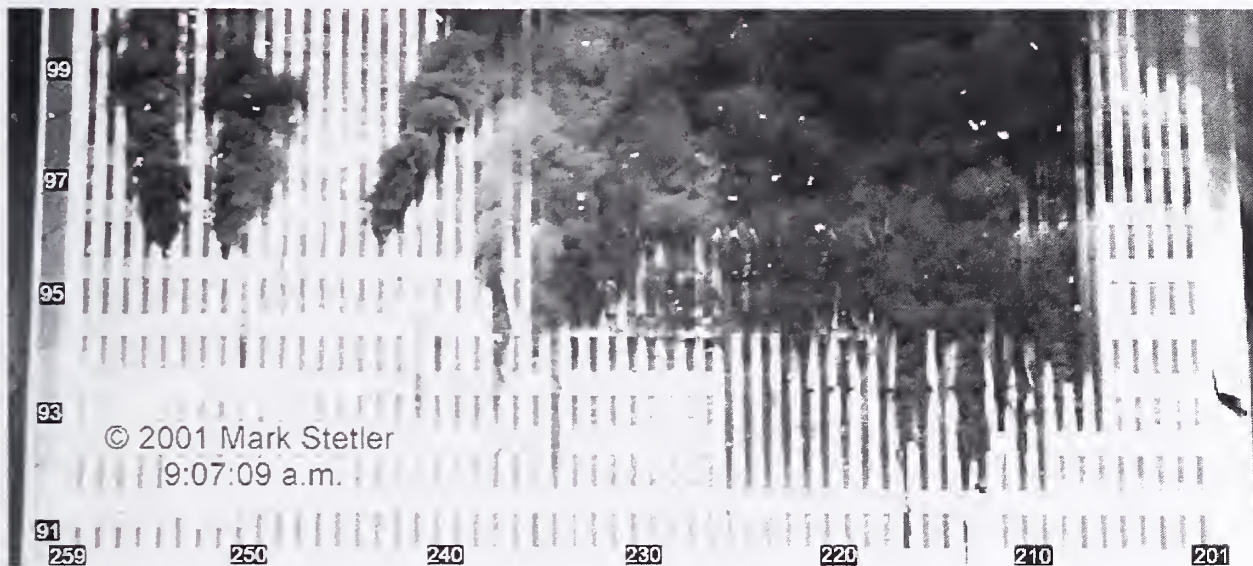
In contrast to the north face of WTC 1, the fires burning on the periphery of the east side of the tower continued to spread during this time period, initiating new areas of intense burning, while areas ignited somewhat earlier were dying down. Figure 8–20 shows the east face at 9:07:09 a.m. The appearance has changed considerably in the four minutes since 9:03 a.m. (see Figure 8–15 and Figure 8–16) and even more so from earlier times. Two important changes are the appearance of extensive areas of flame on the 92nd floor (extending roughly from window 92-216 to window 92-225) and on the 96th floor (visible over at least windows 96-217 to 96-227). Several distinct carets can already be seen on column covers on the 96th floor, indicating that strong external flaming had already taken place from windows adjacent to these columns. At the earlier time there had only been indications of small fires on both of these floors.

Figure 8-20. This cropped photograph shows the east face of WTC 1 at 9:07:09 a.m. It has been rotated slightly and enhanced to emphasize the presence of fire. Column and floor numbers have been added.

The intense fires on the 94th and 97th floors, which developed earliest on this face, have died down considerably in the windows where they were first observed. For an example of the earlier fire distribution, see Figure 8-9, which shows fire locations around 8:59 a.m. At this earlier time, intense burning with flame extension was seen over windows 94-214 to 94-228 on the 94th floor and windows 97-208 to 97-228 on the 97th floor. In Figure 8-20, a region of intense flaming is evident on the 94th floor, extending from window 94-225 to at least window 94-233, with some flame extension in the area, while windows further to the north appear to have little fire present. This shows that the fires on this

floor were spreading to the south at the same time they were dying down in areas that were ignited earlier. The same was true for the 97th floor. At 9:07 a.m., the most intense burning was located near windows 97-218 to 97-229. The largest flame extension was from window 97-226 at this time. At the time the photograph in Figure 8-9 was taken, flames were coming from window 97-208.

Around 9:03 a.m. there was a fire near column 95-225 on the 95th floor. In Figure 8-20, the fire on this floor now extends to window 95-231. The extended flames observed on the 93rd floor near column 93-210 around 9:03 a.m. have receded back into the building and are not obvious in the photograph. In their wake they left a dark caret at the top of the aluminum cover for column 93-210.

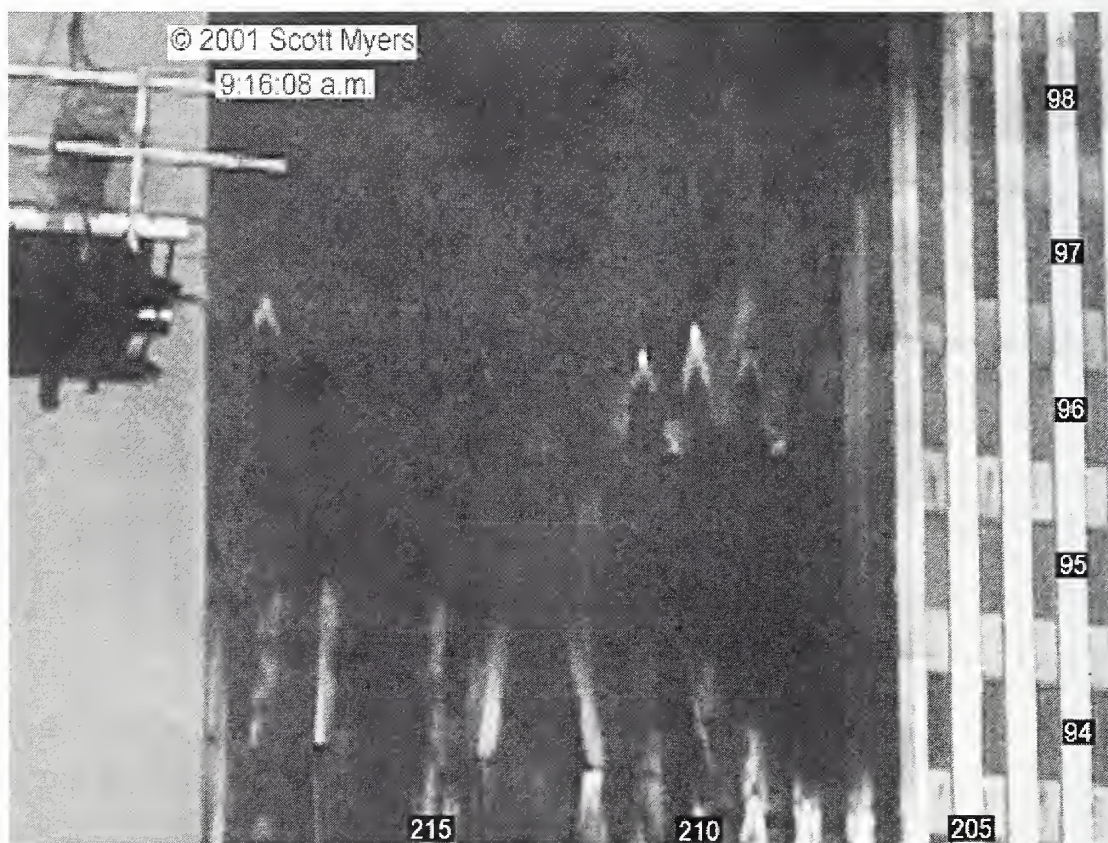
Figure 8-21 shows a close-up frame from a video of a portion of the east face recorded at 9:16:08 a.m. Intense flames are coming from windows 96-208 and 96-209. In the video it is clear that flames are exiting from across the entire burning region that is visible on this floor. A series of carets are seen at the tops of the column covers. The carets appear to be glowing near the center. The physical mechanism responsible for this glow is not known, but it does suggest that significant heating was taking place at this time. Recall that flames were observed on the 97th floor immediately above this location around 8:59 a.m. (see Figure 8-9). These flames are no longer visible, providing additional evidence that flames are growing and then decaying in relatively short period of times.

Figure 8-21. A close up of a portion of the east face of WTC 1 is shown. The image is a frame taken from a video recorded at 9:16:08 a.m. Column and floor numbers have been added. The area to the left with the scaffolding is another building in the foreground.

Even though flames have been observed extending from windows 96-208 and 97-208 on the 96th and 97th floors, the adjacent windows to the north, window 96-207 and window 97-207, are still intact. In fact, the entire area to the east of column 208 on floors 94 through 98 appears to be unaffected by the fires, except for soot deposited on the left side of the area. The sharp demarcation line for the fires on the 96th and 97th floors suggests that fire spread is being inhibited in a manner similar to that already described for the north face. The plan layouts for these floors shown in Appendix B (Figure B-5 and Figure B-6) indicate that both floors had rooms in the northeast corners, with walls that terminated at column 208.

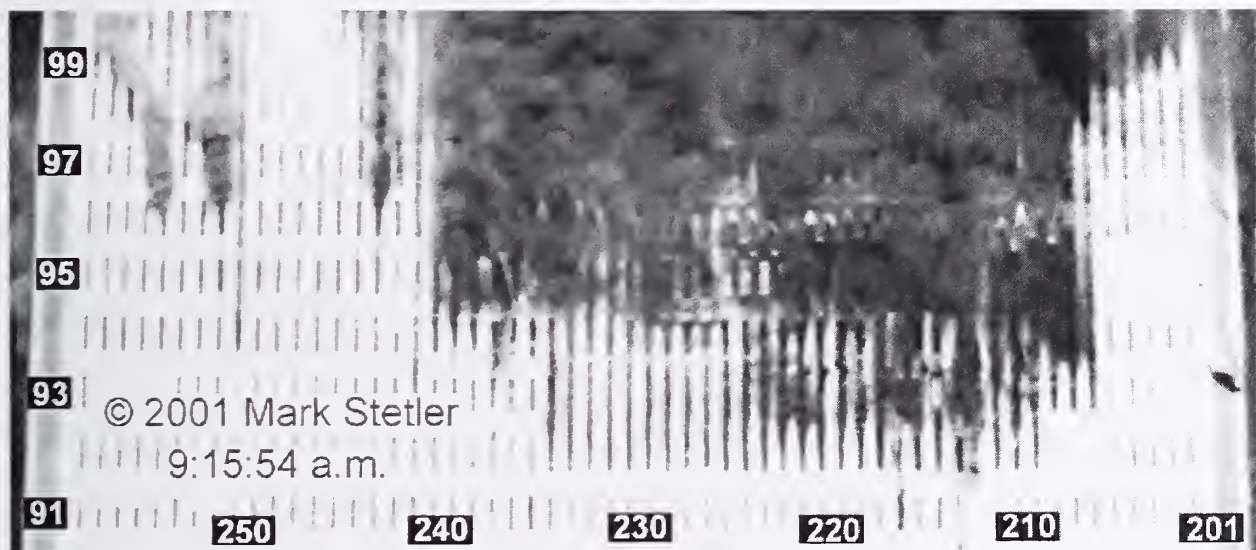
These general trends in the observed fire behavior for the east face continued over the next several minutes. Figure 8-22 shows a photograph that was taken at 9:15:54 a.m. There are regions of extensive fire. Flames can be seen on the 92nd floor from window 92-209 to window 92-235. One curious aspect of these flames is that there is little, if any, flame extension, and there is only heavy smoke coming from windows on the right side of the area. As a result of these characteristics, in many images of the east face recorded around this time, the fire on the 92nd floor is not readily apparent, and the smoke flow from these windows appears to be light. Fire is only observed in images taken nearly perpendicular to the face from relatively long distances. As discussed in Section 4.2.7, such observations are due to the geometry of the building and either suggest the fires are located near the floor or are set back from the windows.

Figure 8-22. This cropped photograph shows the east face of WTC 1 at 9:15:54 a.m. The image has been rotated and enhanced to improve the dynamic range. Column and floor numbers have been added.

On the 93rd floor, there appears to be a small fire covering several windows starting at window 93-206. There is some smoke coming from the area.

Unlike earlier, at this moment, only limited flame extension is observed from windows on the 94th floor. Flames can be seen inside the windows starting near window 94-224, and they have now spread as far south as window 94-240. Even though smoke is still coming from some windows, there is little flame evident in windows to the north of window 94-223.

Some of the 97th floor is hidden by smoke. This is especially true near the center of the face, where a substantial fire may still be present. Many open windows can be seen to the north of this area in which there does not appear to be fire present. In other places, e.g., near window 97-211, relatively low-level burning is taking place. Similar to part of the 94th floor, the fires on the 97th floor that grew the earliest on this face now appear to have died down.

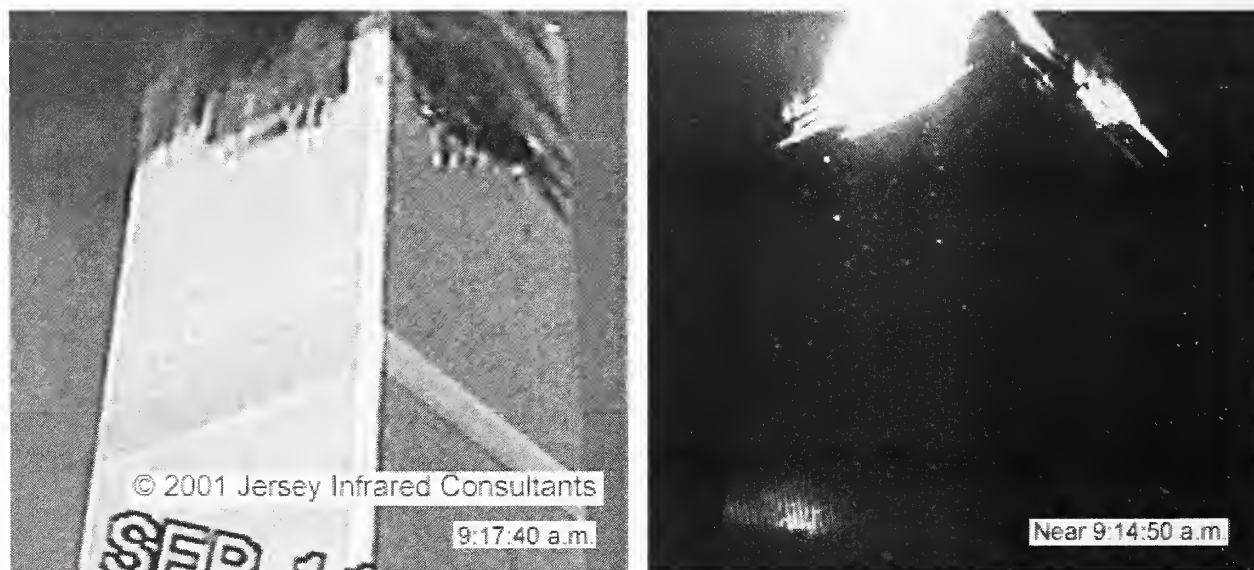
An infrared image showing the north and east faces of WTC 1 that was taken around 9:14:50 a.m. is compared in Figure 8-23 with a standard video frame recorded shortly afterward from the same location. These images were recorded at roughly the same times as Figure 8-19 (9:18:17 a.m.) and Figure 8-22 (9:15:54 a.m.), which show the north and east faces of WTC 1, respectively. Recall from the earlier discussion that the infrared photographs provide only a qualitative indication of where heating of the building façade is taking place.

Figure 8-23. A frame from a standard video camera (left) and an image from an infrared camera (right) showing the north and east faces of WTC 1 are compared. The video frame was shot at 9:17:40 a.m., and the infrared image was taken around 9:14:50 a.m. (an uncertainty of 15 s has been assigned). The infrared image intensity levels were adjusted. The video frame has been rotated and sized to match the infrared image.

The appearance of the north face in the current infrared image differs considerably from that observed around 8:55:55 a.m. in Figure 8-7. The primary reason for this is that the amount of smoke flow from the

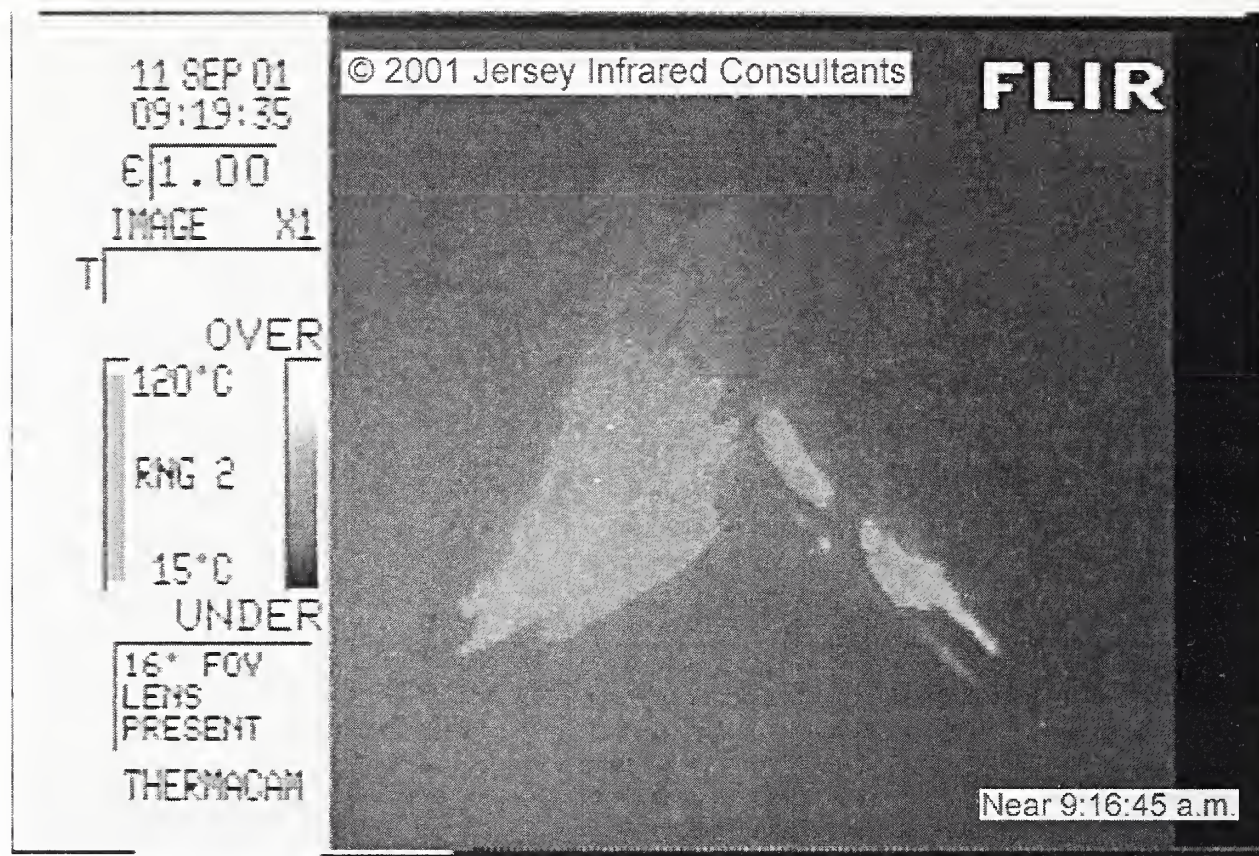
The difference in the amount of heating on the north and east faces in Figure 8–23 and Figure 8–24 is striking. Much of the area above the fires on the 92nd floor at the center of the east face is saturated, i.e., strongly heated. This is likely due to the large amounts of smoke and heat flowing from open windows near the intense fires burning on multiple floors of this face.

Figure 8-24. This frame from a standard video recording of the display from an infrared camera shows the north and east faces of WTC 1. It was shot around 9:16:45 a.m. (an uncertainty of 15 s is assigned) using a false-color scale for intensity. The output is strongly saturated.

On the northern side of the east face there are heated areas that reach as far as the northeast corner on the 96th and 97th floors. This is clearer in Figure 8–24, which shows more of the tower. Recall that at the times these images were taken the glass for all of the windows inside the northeast corner rooms was still in place on these floors despite the presence of nearby intense fires. On the lower floors there appears to be mild heating at the northern edges of the 92nd and 94th floors, while the 93rd and 95th floors are close to the ambient temperature.

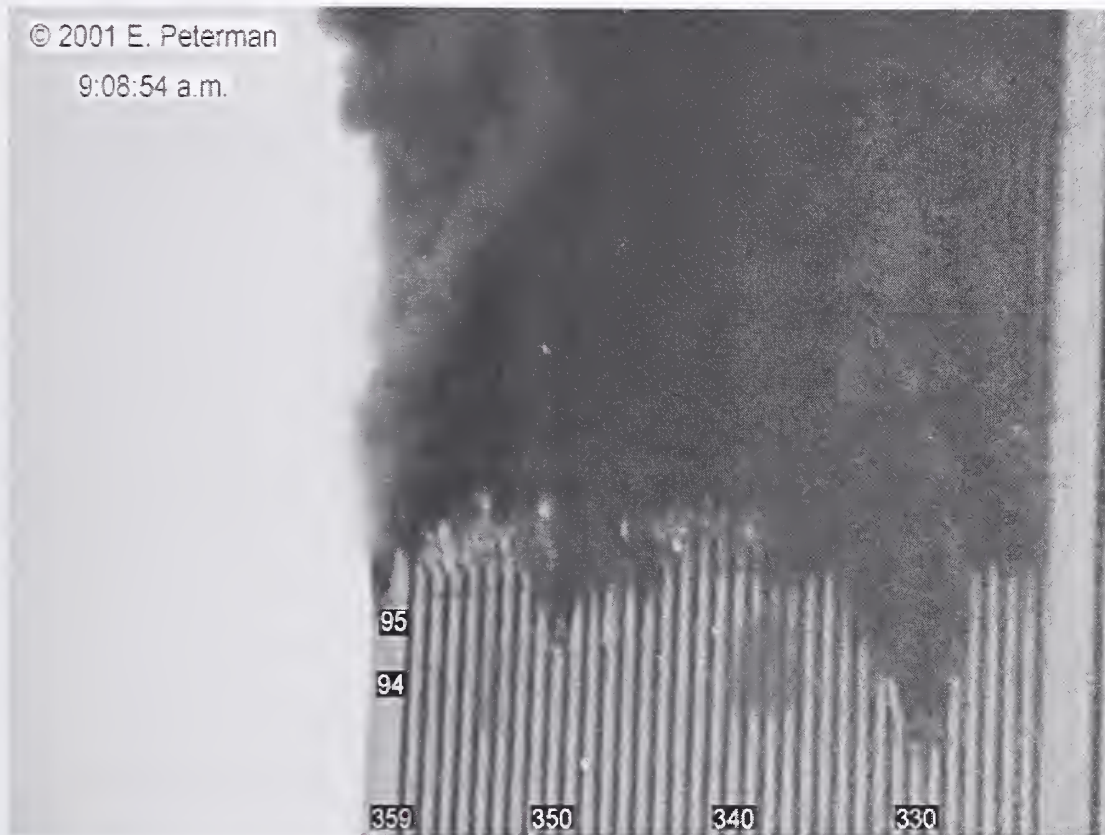
During the initial part of this time period, the fires on the west side of the 96th floor on the south face continued to spread and grow. Distant images indicate that fire fully covered the area near the west wall shortly after 9:03 a.m. Figure 8–25 shows the west side of the south face as it appeared at 9:08:54 a.m. The image was captured from a video recording. On the 96th floor, flames now extended from at least

window 96-335 all the way west to window 96-358. The flames were particularly heavy on the west edge from windows 96-350 to 96-358. At this time, flames are not visible on other floors.

Figure 8-25. This image showing the south face of WTC 1 at 9:08:54 a.m. is a frame taken from a video. Column and floor numbers have been added.

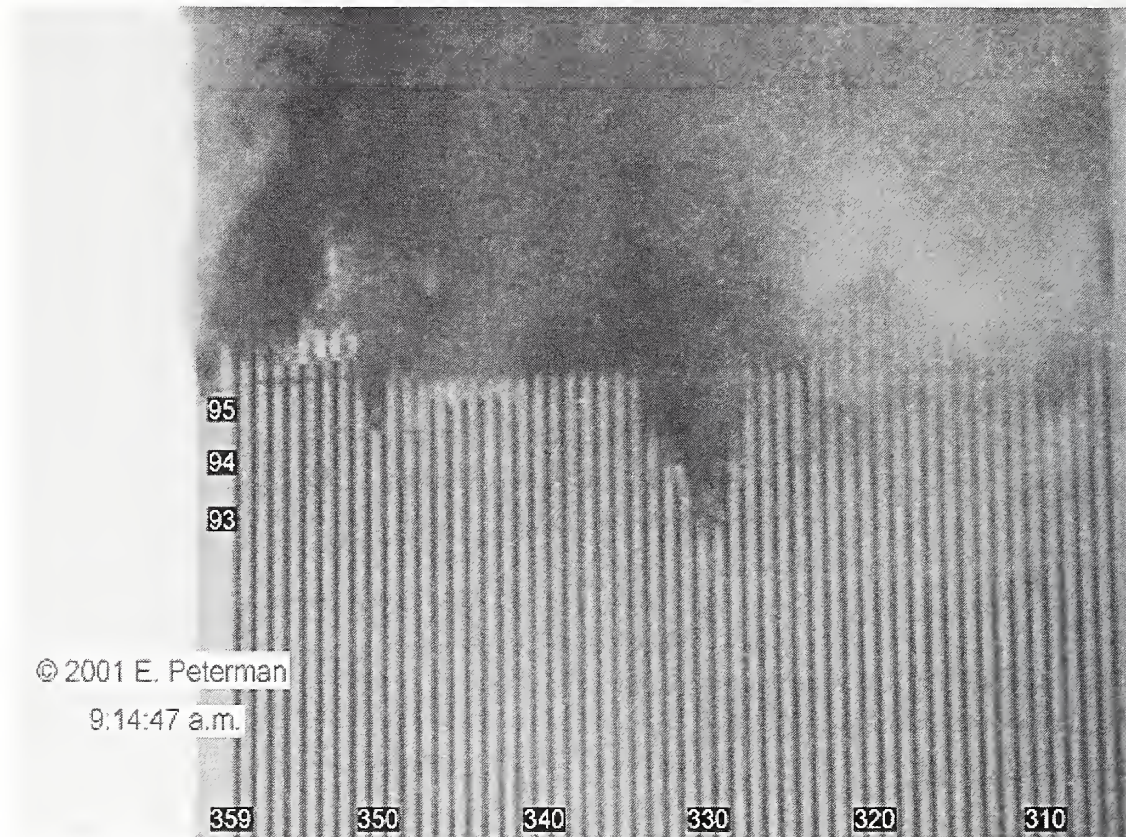
During the next five minutes, the appearance of the south face changed dramatically as can be seen by comparing Figure 8-25 with another captured video frame shown in Figure 8-26. While the fires on the 96th floor were beginning to die down and recede back into the tower, extensive areas of flame were now apparent on both the 95th and 97th floors. The fire on the 95th floor can be seen in windows 95-340 to 95-346, while flames are visible extending from windows 97-336 to 97-354 on the 97th floor. The fire on the 97th floor may actually extend to the west face, but this cannot be confirmed since the area was hidden by heavy smoke coming from below.

Even though the west side of the south face is heavily involved in flames, there has been no apparent fire spread toward the east beyond the initially damaged area near the center of the face.

Figure 8-26. This image showing the south face of WTC 1 at 9:14:47 a.m. is a frame taken from a video. Column and floor numbers have been added.

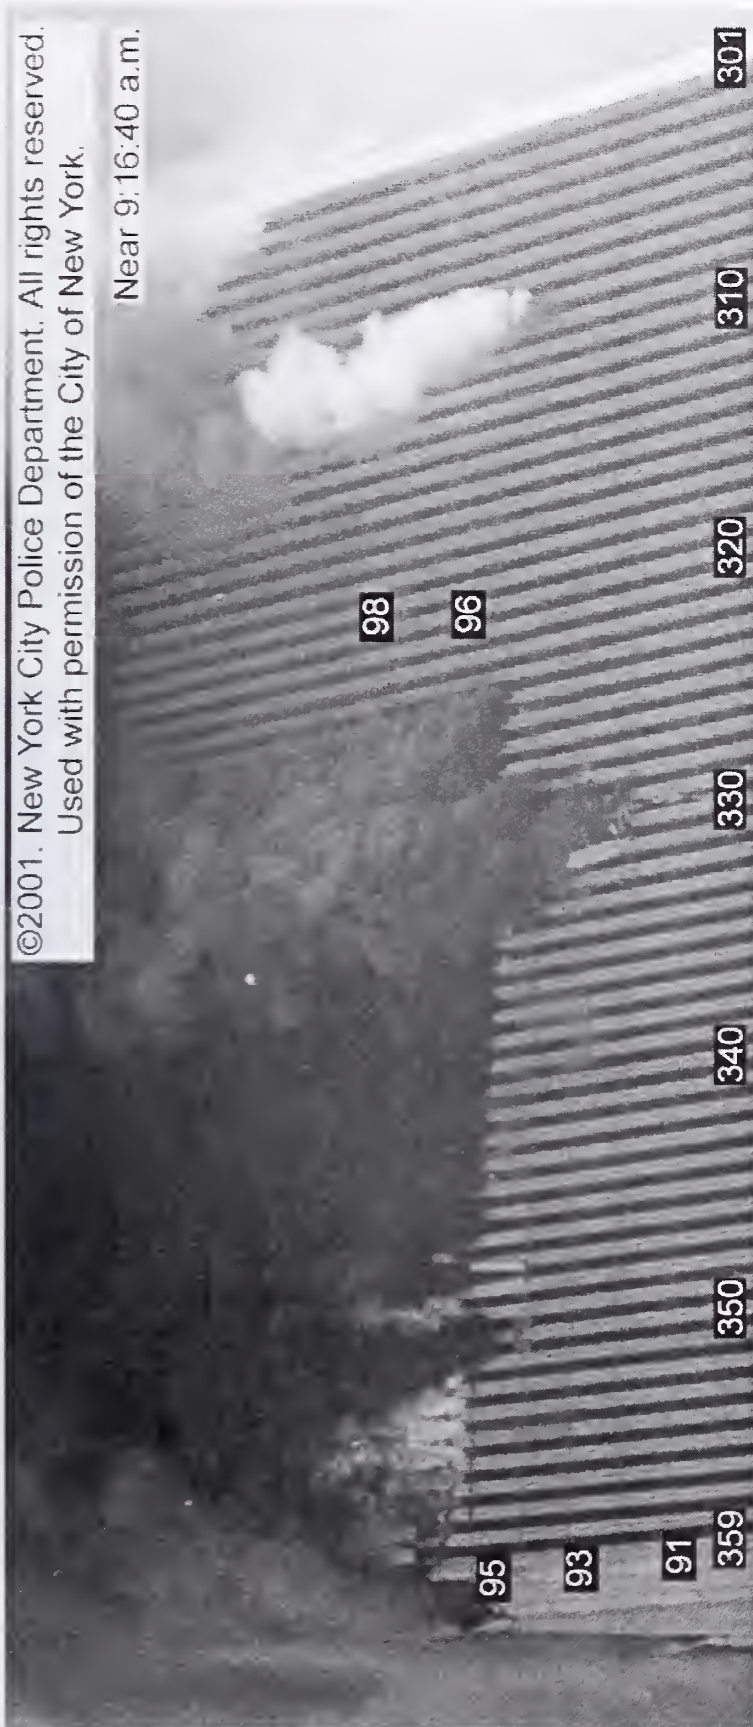
The fire intensity on the south face appears to have gone through several cycles, alternating between periods during which flames extended large distances from multiple windows and those where the flames receded back into the building. Figure 8-27, a photograph shot at around 9:16:40 a.m., i.e., roughly two minutes later than Figure 8-26, shows an example of one of the intense burning periods. The fire on the 95th floor has spread to the east and now extends to at least window 95-333. Flames are coming from several windows to the left of window 95-340. Heavy smoke, which partially obscures the areas above, is pouring from the openings. Bright yellow flames, which appear to reach down to the bases of the

windows, are now jetting from multiple windows on the 96th floor. It appears as if a portion of the exterior wall is covered by a continuous sheet of flame several stories tall. Fire is evident on the 97th floor, but it is not possible to judge whether flames are coming out of the windows on this floor due to the heavy smoke and flames rising from the 95th and 96th floors.

A row of carets is already visible at the tops of the covers for columns 96-352 to 96-359. Despite the intense flames, few streamers were observed falling from the south face as shown in Appendix L. This is not unexpected since imagery from this direction is more limited than for the north and east faces, and many of the available shots are from such distances that streamers are difficult to identify. During this time period, the south face was in shadow, and streamers were not illuminated by sunlight until they had traveled a considerable distance from the building.

Figure 8-27. This image of the south face has been cropped from a high-resolution photograph. There is a 35 s uncertainty in the assigned time of 9:16:40 a.m. The image has been enhanced and rotated. Column and floor numbers have been added.

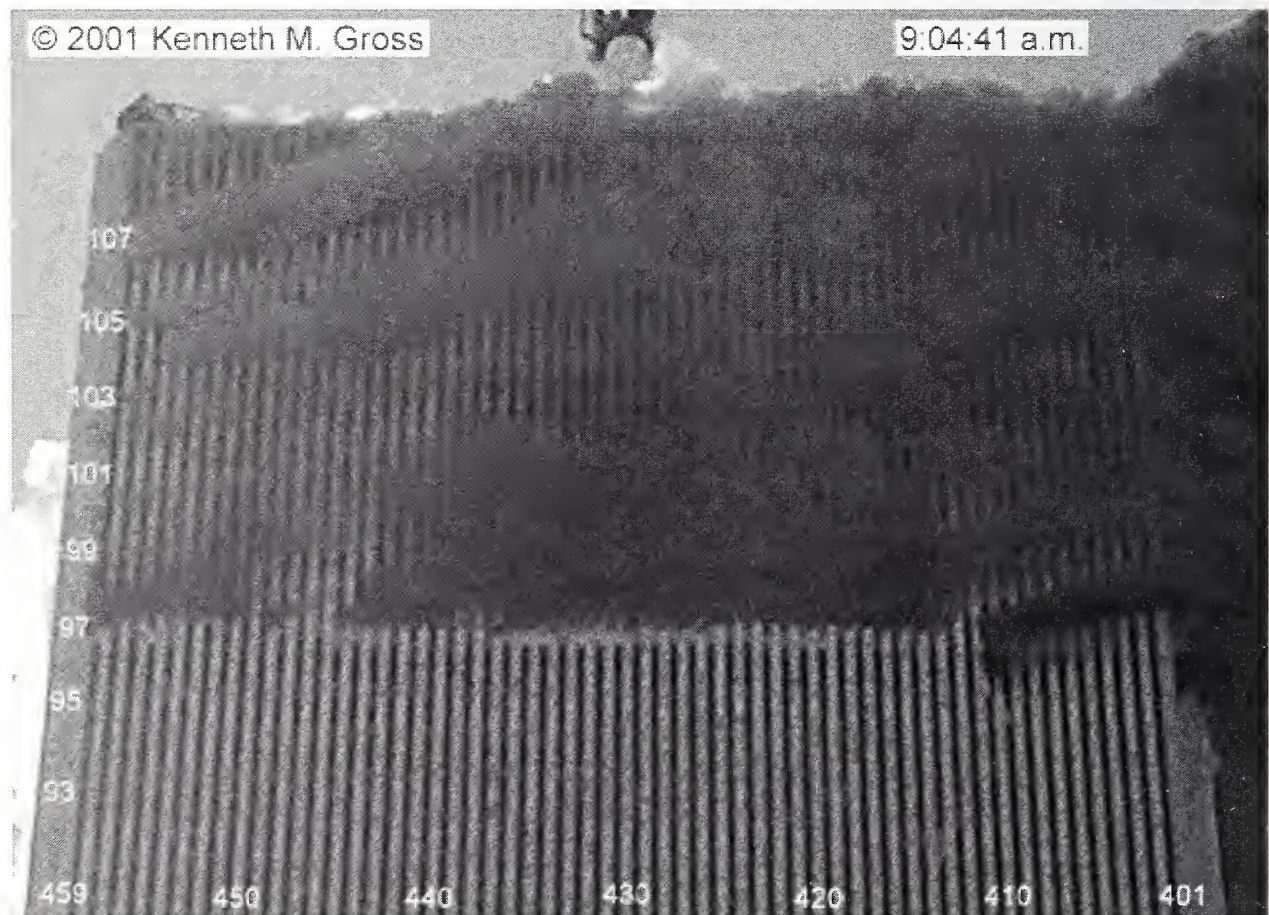
The fires on the west face during this time period continued to undergo unusual and dramatic changes in behavior. But first, following the two periods of rapid fire spread prior to 9:03 a.m., the fires again underwent another pause during which further fire spread was not evident. Figure 8-28 shows the west face as it appeared at 9:04:41 a.m. Flames, with a couple of breaks, can be seen in or extending from window 97-412 to window 97-458. This is roughly the same area that was burning just prior to 9:03 a.m., although the flames in the southern part of the area are more evident than earlier. Heavy smoke is pouring from multiple windows on this floor. Other features present in Figure 8-28 include heavy smoke flow from windows 96-409, 96-410, 97-409, and 97-410 on the 96th and 97th floors, the heavy smoke coming from broken windows in the upper northern portion of the face, and the fire coming from the southwest corner of the 96th floor where the aluminum panel was dislodged during the aircraft impact and subsequent fireball. A streamer can be seen near column 414 at the bottom of the photograph.

The open windows on the 95th floor, visible in Figure 8-11, can also be seen in Figure 8-28. There are also four windows, 94-434 to 94-437, on the 94th floor that are now open, but were in place in the earlier photograph taken at 9:01:40 a.m. These windows are believed to have been broken out by people. At this time there is no smoke coming from either set of open windows despite the presence of fires elsewhere on both floors.

Figure 8-28. A cropped photograph of the west face of WTC 1 taken at 9:04:41 a.m. is shown. The image has been enhanced and rotated. Window and floor numbers have been added. A streamer can be seen falling near the bottom of the image at column 414.

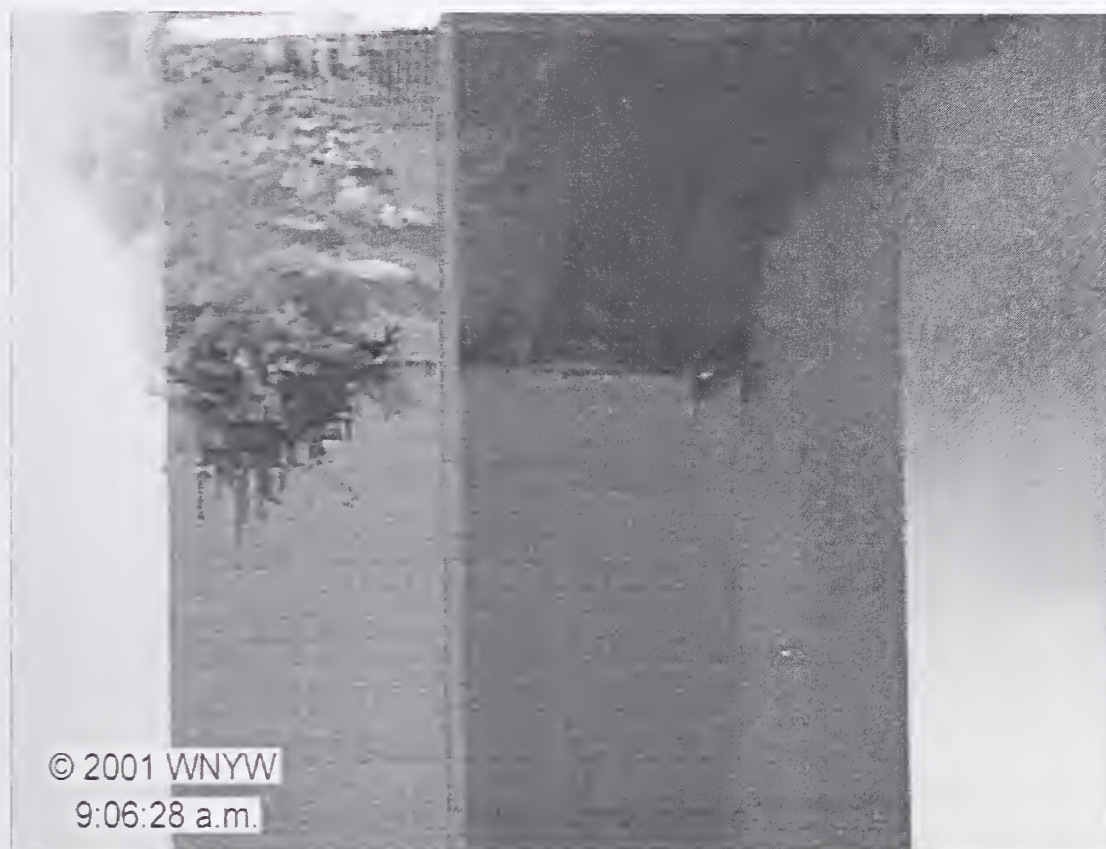
Mostly long-distance photographs and videos show that the conditions present in Figure 8–28 did not change appreciably until 9:06:27 a.m. At this time a short-lived, but intense, burst of flame appeared near the top of window 97-408, as can be seen in Figure 8–29. Very shortly after this flame appeared, the amount of smoke coming from open windows on the 97th floor decreased dramatically, and it was possible to see parts of the west façade that had been hidden just before. The heavy smoke is still evident in Figure 8–29.

Figure 8-29. This image of the north and west faces of WTC 1 is a frame from a video recorded by a news helicopter at 9:06:28 a.m. WTC 2 can be seen behind WTC 1. Note the burst of flame from near window 97-408 at the southwest corner of WTC 1.

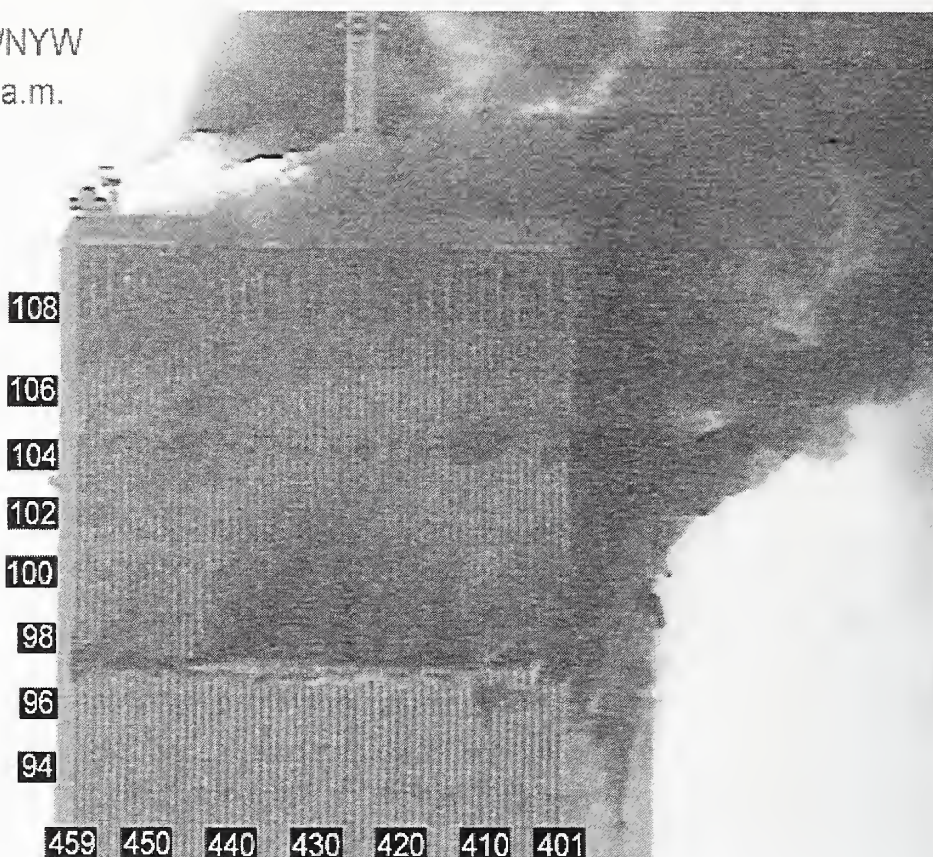
Another frame taken from a video shot by a news helicopter is shown in Figure 8–30. This image was taken four and a half minutes later than Figure 8–29. An extensive area of flame is still present on the 97th floor, but the flames toward the center of the face appear to have receded deep inside the building. There is very little smoke coming from the region. Most of the west face is now visible. In particular, the smoke coming from two areas on the south side of the face at the 104th floor can now be seen clearly. On the north side of the face the heaviest smoke flow from the upper floors is coming from the 107th floor, with strong smoke plumes also issuing from open windows on the 104th and 105th floors.

There appears to be a small fire on the 96th floor at window 96-406. Small fires such as this one were not observed on the west face of the 96th floor until around 9:08 a.m. This was the case despite the fact that an intense fire had been burning just around the southwest corner on this floor for over 20 minutes. Several windows did open near the corner during this time period, suggesting that heating was taking place in the area. There is a remarkable difference in the fire growth and spread on the western

Figure 8-30. This image of the west face of WTC 1 and an oblique view of the south face is a frame from a video recorded by a news helicopter at 9:10:58 a.m. Column and floor numbers have been added.

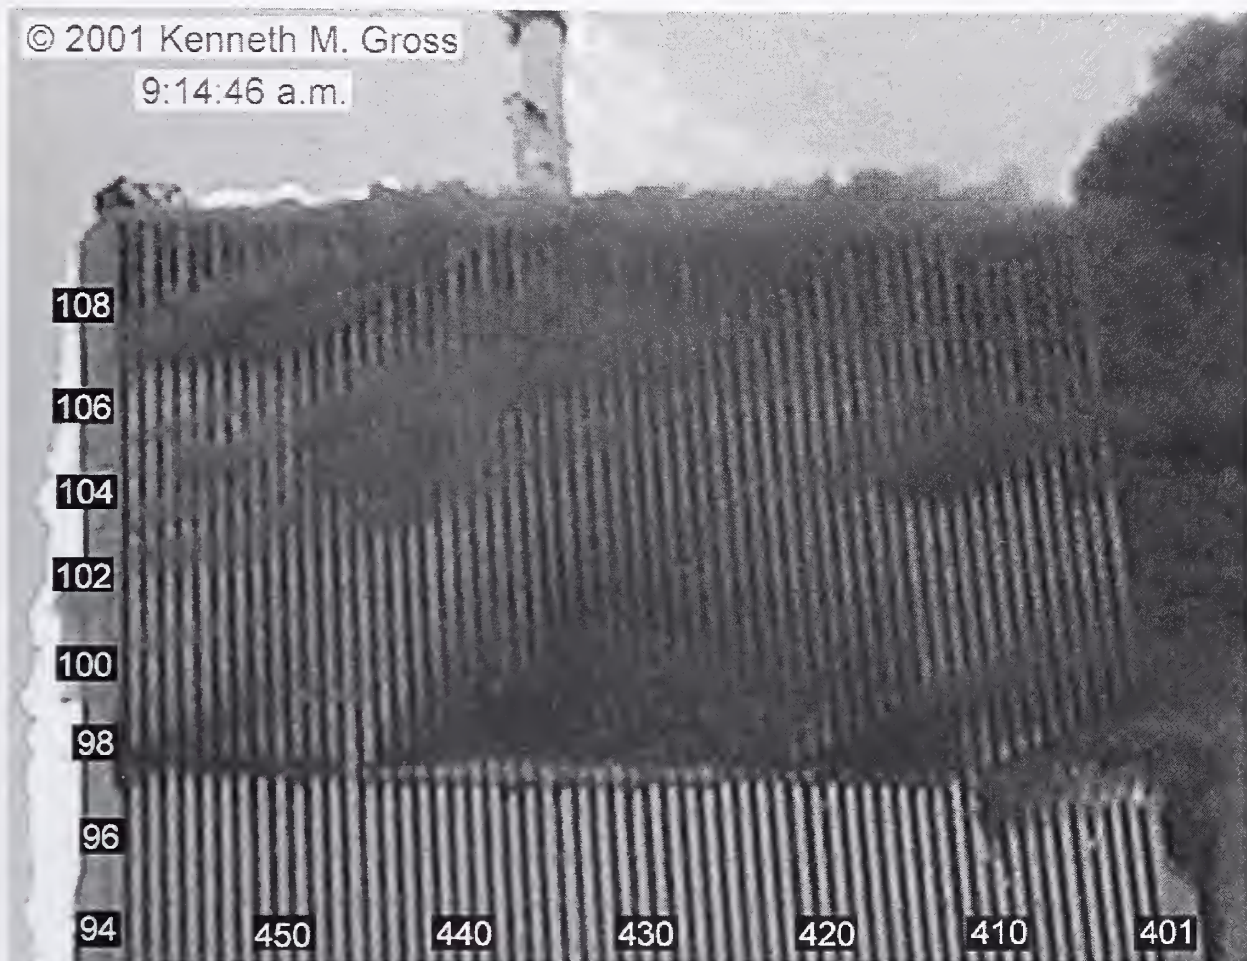
A higher resolution photograph of the west face taken at 9:14:46 a.m. is shown in Figure 8–31. The photographer was located just to the west of the WTC site and was, therefore, shooting up at the building from a steep angle. The only area in which fire is evident in this photograph is on the 97th floor at the south edge in windows 97-401 to 97-406. While the flame lengths are fairly short, there does appear to be some flame extension from these windows. The smoke plumes from higher floors described above are also visible, and a spot fire is present in window 96-404. There are still no indications of smoke or fire on floors below the 96th.

Figure 8-31. This cropped photograph shows the west face of WTC 1 at 9:14:46 a.m. It was shot from the ground a short distance from the WTC site. Column and floor numbers have been added.

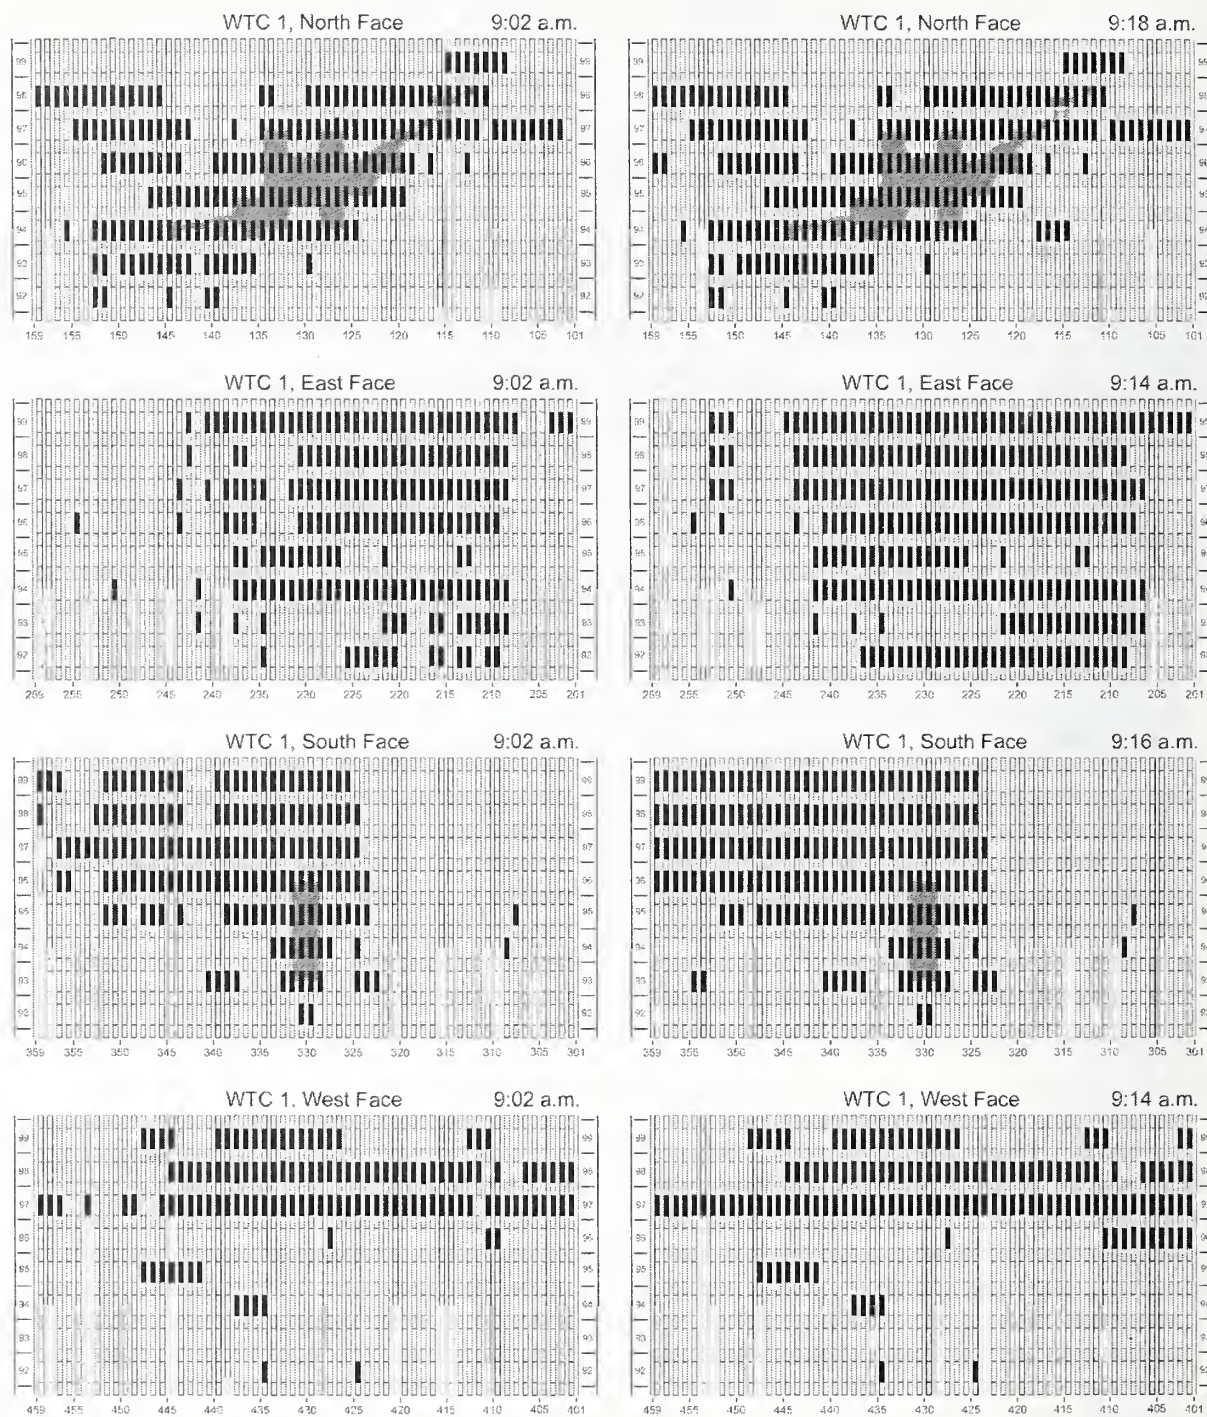
In Figure 8-32, window breakage is used as a surrogate for fire spread to provide a visual indication for fire growth during the period covering roughly 9:03 a.m. to 9:18 a.m. It should be kept in mind that open windows do not provide a perfect history of fire locations since many windows were broken during the aircraft impact and accompanying fireballs. It is also likely that some of the windows that were open at this time were broken by people. This is particularly the case on the 94th and 95th floors on the west face.

Figure 8-32. Maps for the 92nd through the 99th floors compare missing window glass for the four faces of WTC 1 at two times, around 9:02 a.m. and roughly 15 minutes later. The color coding used for the maps is indicated in Figure 5-1.

In Section 6.4.2 it was pointed out that the aircraft and fireball damage to the tower was asymmetrical and that the southeast quadrant appeared to be relatively undamaged. Figure 8–32 and Figure 8–33 show quite distinctly that major fire development has not yet occurred at the periphery of this quadrant. This is further evidence that aircraft debris and/or fuel did not reach the periphery of this quadrant to any great extent.
